## An interview with Lee Caswell on the restoration of the “Checkered Cottage” in Port Hope, Ontario

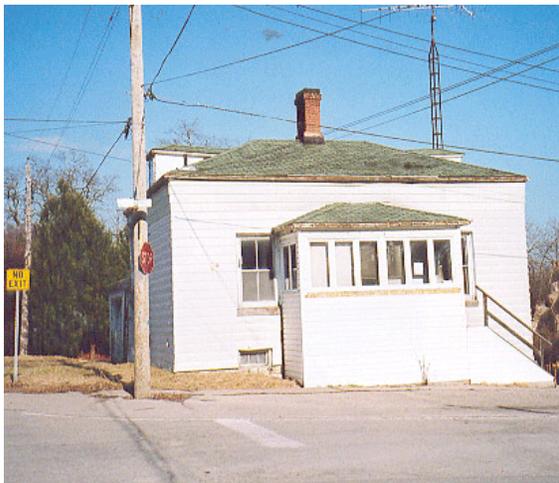
Before

You are correct! The original photo shows little appeal, at least from the curb. For starters, look at the cornice of the building; it is done in pale green aluminum. It swells slightly as it meets the roofline. This to me suggested a cornice or stepping at the roofline.

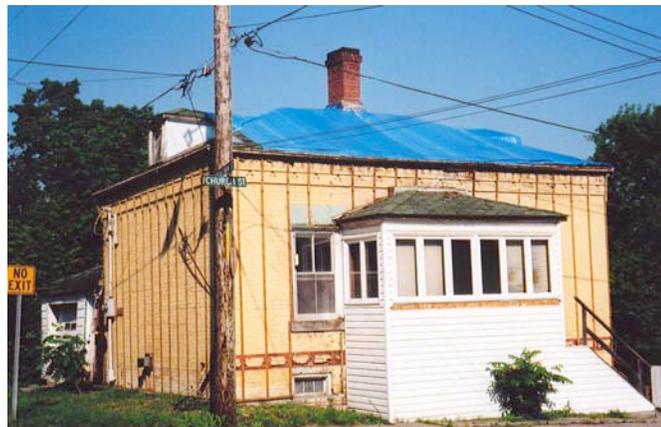
As you can see from later photos we uncovered a brick house with paint present. The aluminum covering made it difficult to analyze the condition from the outside, prior to our “metal-peel”, après purchase. Luckily, I say that for me only, the house was plaster on brick construction. This meant I could assess the condition of the structure, from the inside by looking at the plaster/brick condition. I found it was in pretty good condition, save for one corner, which through neglect suffered water damage. Indeed, on the outside, some aluminum was loose and the brick cornice was visible at the rear of the house. However, the bricks

had been “chopped off” to accommodate the aluminum siding and wooden strapping.

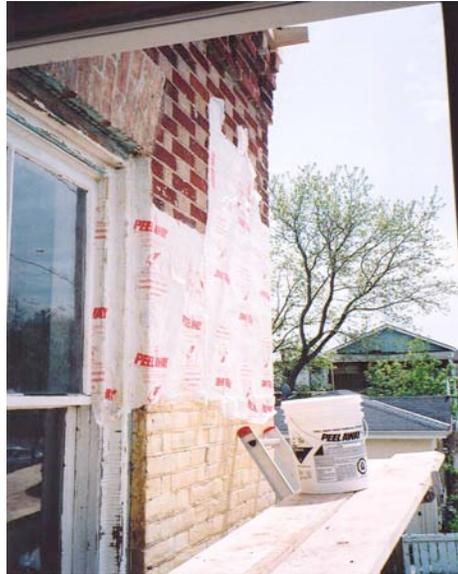
I took a light-handed approach in removing layers carefully, so not to destroy any original features. Layers disappeared and what emerged was a painted brick house with chopped bricks where they impeded the Aluminum man. What also appeared under the porch (never painted) was the 2-tone brickwork (piebald or checkerboard pattern) on the front face of the house.

Painted brick was, I believe a “solution” to seal a house from draft; just as aluminum did at a later date. What do these two attempts to seal this house tell you? That it was very cold and drafty. My original intent was to simply paint the house, but upon discovering the checkered pattern, I felt a gun was to the head to carefully clean and restore the brickwork. We secured two colours of brick in the proper size from the Niagara area,

through the noted Restoration Architect, Peter Stokes; and a young graduate from an historic masonry course began the long process of chipping out the damaged brick and replacing it with the proper colour. I did the brick cleaning myself ... a task I wish to never repeat!

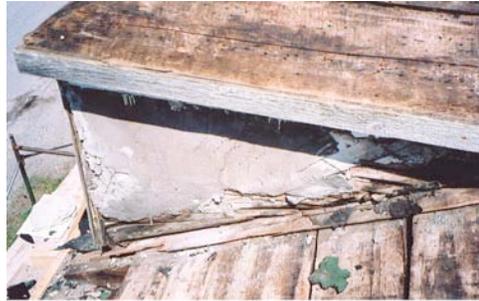
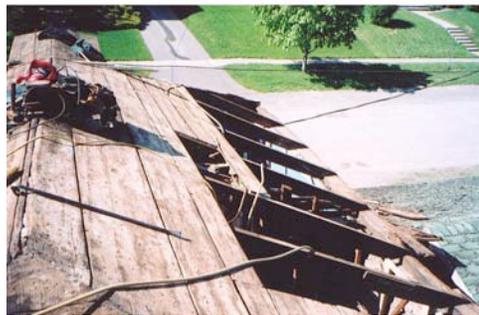
At the same time the brickwork project was ongoing, practical things like a repaired and waterproof roof were a priority as there were many layers of asphalt shingles present, most in a deteriorated state.

We removed them and any rotted roof boards (about 40%) and replaced them with pine boards as before. The roof plate (the beam which connects the roof structure to the brick walls contained a fair bit of rot. It was chiseled away and replaced where necessary thus giving a solid attachment point for the eaves, which were completely missing. Many houses from this era contained internal gutters and I concluded these had been present at one time. An internal gutter is basically a hollowed out log lined in sheet metal where the rainwater flows. They are an elegant feature giving a horizontal line at the eave level. The internal gutter is an item found in England where they worked fairly well I presume; but in our cold Canadian winters especially in southern Ontario we have constant freeze-thaw, these gutters even with modern liners don't stand up well.

I designed a pseudo internal gutter using moldings found on the dormers (original moldings), but the main difference is there is a traditional eaves trough at the end of the eave. A mock-up of the gutter was constructed and tacked in place. Dimensions were found on nearby cottages and were a starting point for the scale. We torched on a waterproof membrane on this as well and it worked like a charm. Now that the roof and eaves were secure, work on the interior and construction of the new addition could commence.
